National Transportation Safety Board

Highway Accident Brief

Accident No.: HWY-08-FH-018
Accident Type: School bus struck in left rear by automobile, loss of control, and rollover
Location: Interstate 10, ten miles east of Milton, Florida
Date and Time: May 28, 2008, 9:30 a.m. central daylight time
Vehicle One: 2002 Bluebird/International 65-passenger school bus
Motor Carrier: Okaloosa County School District
Occupants: Driver and 17 passengers (14 children and 3 adults)
Injuries: 2 serious and 14 minor; 2 uninjured
Vehicle Two: 2002 Chevrolet Tahoe 4-door sport utility vehicle
Operator: Private owner
Occupant: Driver
Injuries: None

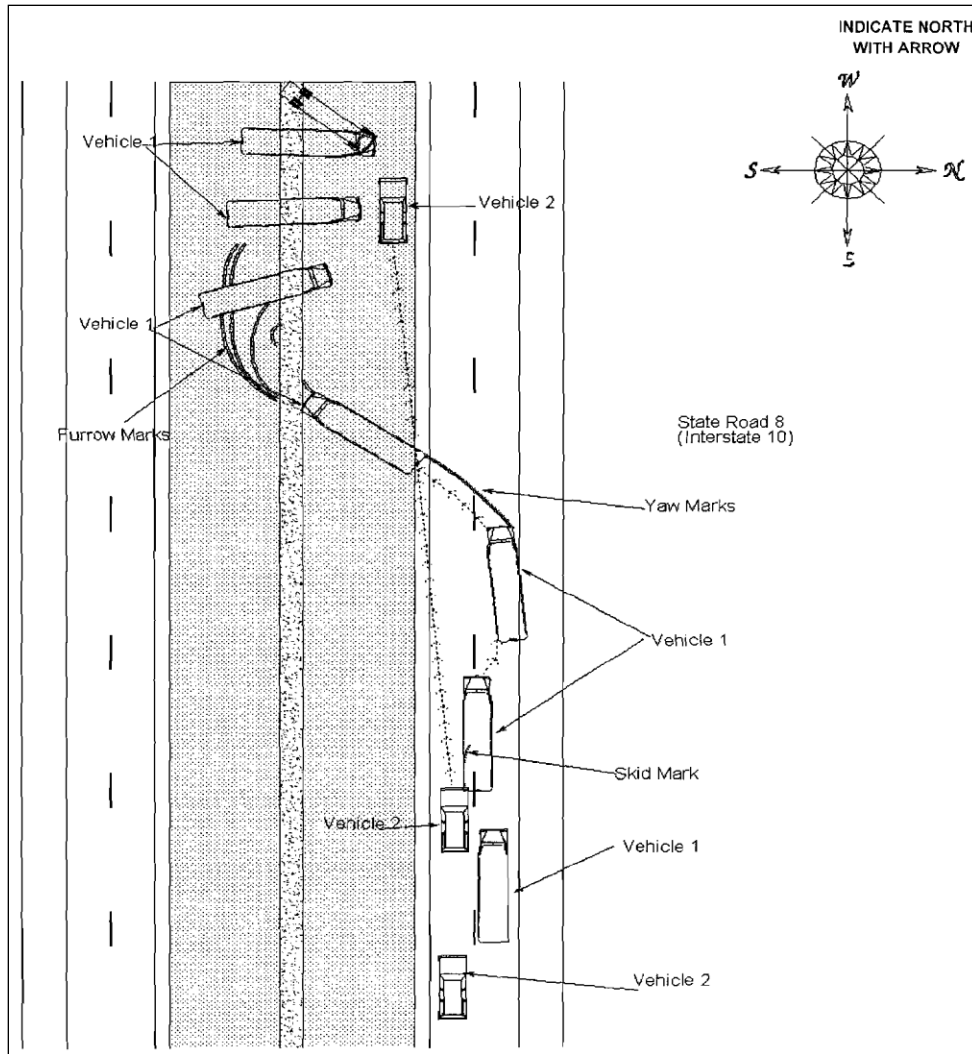
The school bus was traveling in the right traffic lane at the vehicle's governed maximum speed of 55 mph when, for unknown reasons, the bus driver drifted partially into the left lane of I-10 westbound. At the same time, a 2002 Chevrolet Tahoe was traveling westbound in the left lane at a driver-estimated speed of 70–75 mph. As the Tahoe was passing the school bus, and the school bus drifted into the left lane, the Tahoe's right-front bumper struck the left-rear bumper of the bus. The roadway is flat, and the posted speed limit is 70 mph at the accident location. (See figure 1.)

Figure 1. Police scene drawing of accident vehicle dynamics. (Source: Florida Highway Patrol.)

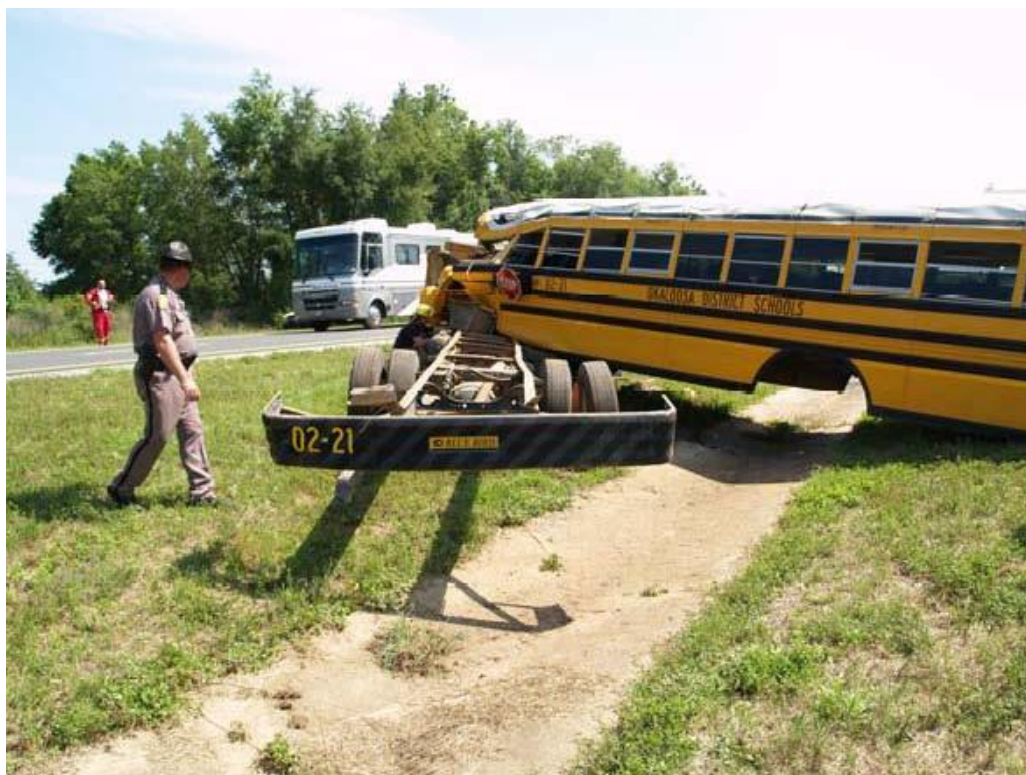
As a result of the impact and difference in vehicle bumper heights, the right-front bumper of the Tahoe became snagged on the left-rear bumper corner of the school bus, and both vehicles remained in contact for approximately 17–18 feet.¹ As a result of the impact from the rear by a vehicle traveling at a higher rate of speed, the school bus veered back into the right lane and dragged the Tahoe into the right lane, where the vehicle’s bumper then separated. The Tahoe slowed and continued forward onto the left shoulder and grass median of I-10, while the school bus passed the Tahoe and continued onto the left shoulder and grass median and began to yaw counterclockwise. Furrow marks in the center median indicate that, after the bus entered the median, it began to rotate clockwise as it reached the center of the median. After the front-left tire of the school bus began to plow into the earthen median, the bus overturned. Physical evidence at the scene indicated that the bus rolled over at least twice (720 degrees) before

coming to final rest. In addition, the bus body separated from the chassis at a point just beyond the engine unit rearward. (See figure 2.)

Figure 2. Final rest position of bus body and chassis.

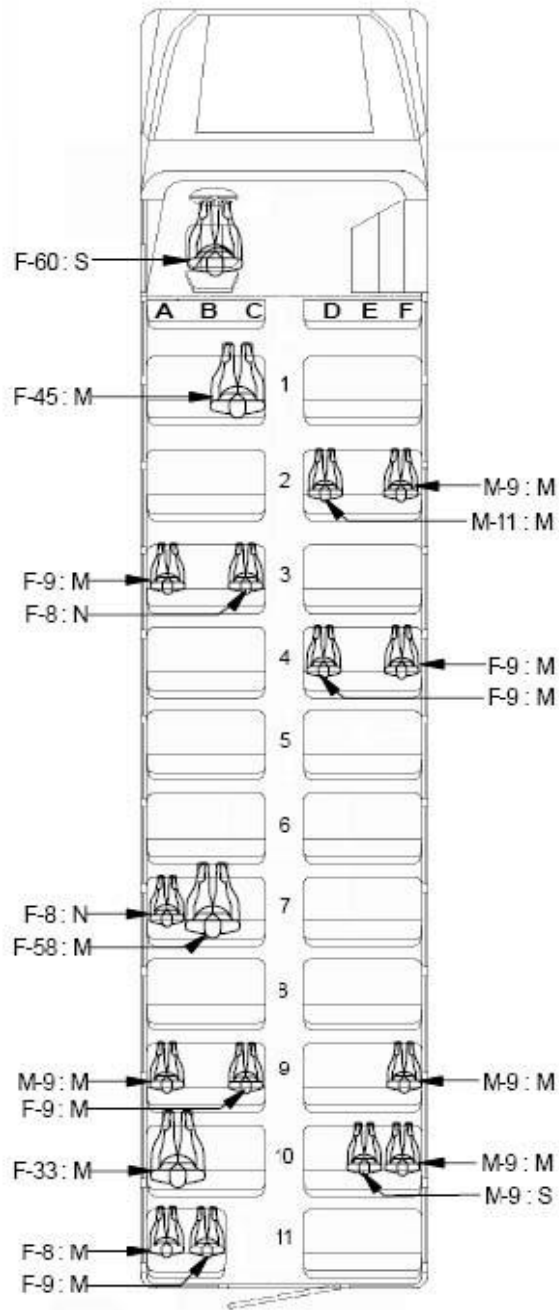
Passenger seating in the accident school bus was arranged into 11 rows with three passengers per seat on each side of the bus, except for the last seat on the left side, which was designed for two occupants to provide adequate space for the rear emergency exit door. (See figure 3.) Both the two-person and three-person seats were equipped with IMMI lap belts⁵ for each seating position. The driver’s seat was equipped with an IMMI lap/shoulder belt.

Two passengers (9-year-olds in seats 9F and 10E) reported that they either slipped out from under the lap belt or that the belt unlatched during the overturn sequence. Both reported that they wore the lap belt loosely, which may have permitted enough movement during the vehicle’s 720-degree rollover to allow occupants to become free of the lap belt. Only one of these two passengers (seat 10E) sustained serious injuries, which included a clavicle fracture, a fracture to the humeral head, and scalp lacerations. The other passenger (seat 9F) sustained minor contusions, lacerations, and knee sprains. None of the bus passengers, including these two passengers, were ejected from the school bus during the overturn sequence.

Figure 3. Bus seating chart.
